Narrow cross sections without centre line markings – “2 minus 1” rural road

Road user behaviour study Summary Note

June 2007

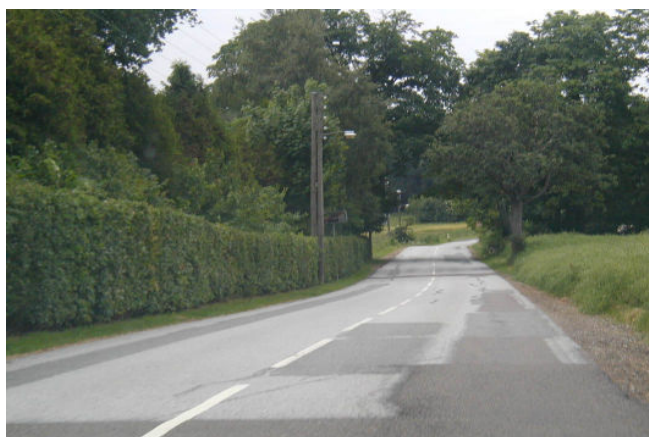
Figure 1: Before situation. Two lane rural road with centre line marking

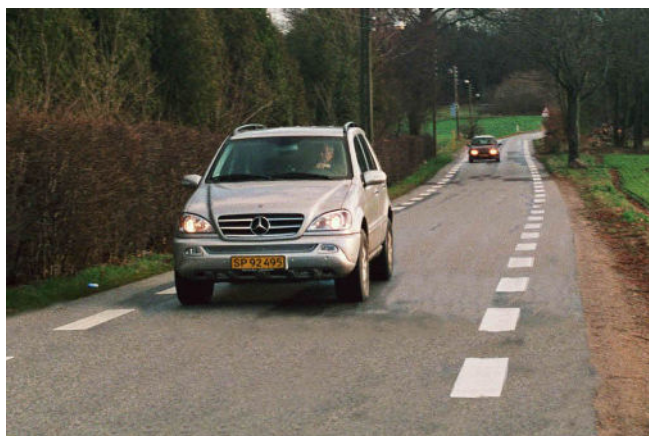
Figure 2: After situation. One central driving lane

In the new “2-1”- profile the centre line marking has been deleted. The redesigned road have only one central driving lane – 3.5m width – marked by 0.30m wide intermittent edge lines leaving an area of 0,85m width in both sides for cyclists and for cars to use in meeting situations (Figure 2)

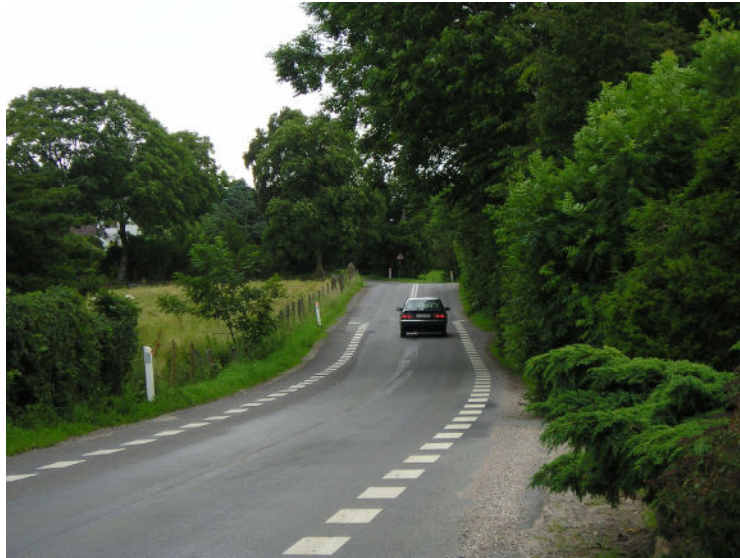
Figure3: Centre line marking is remained in curves when "stop sight distance" is too short.

In curves where stop sight distance is too short for the “2-1”-solution the profile has remained as a two lane rural road with centre line marking (Figure 3).

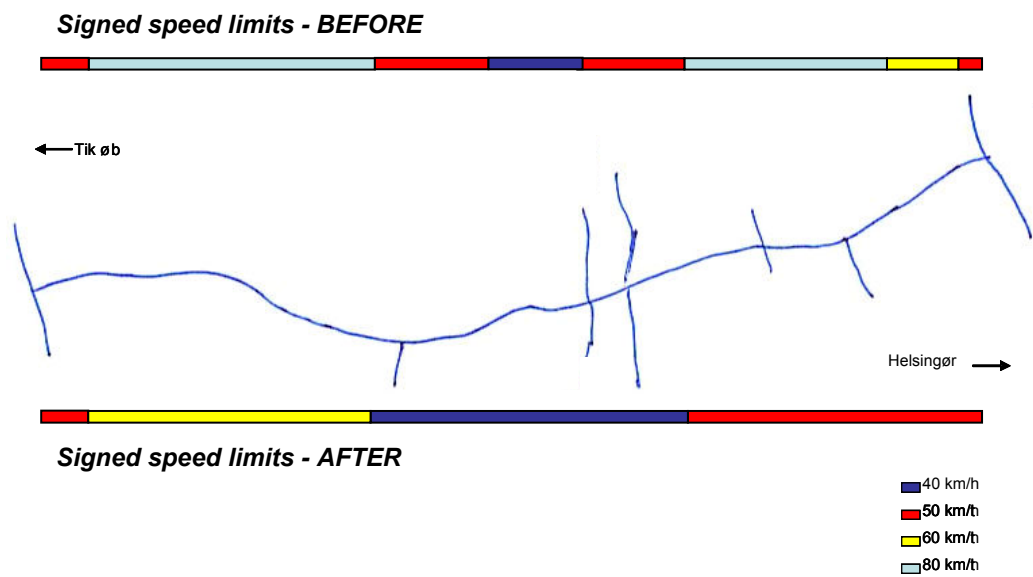
Edge lines are related to signed speed limit

The length and spacing of the intermittent edge lines are longer the higher speed limit:

Signed speed limit	Length of spacing
60 km/h	2m – 2m – 2m – 2m -
50 km/h	1m – 1m – 1m - 1m -
40 km/h	½ m - ½ m - ½ m - ½ m -

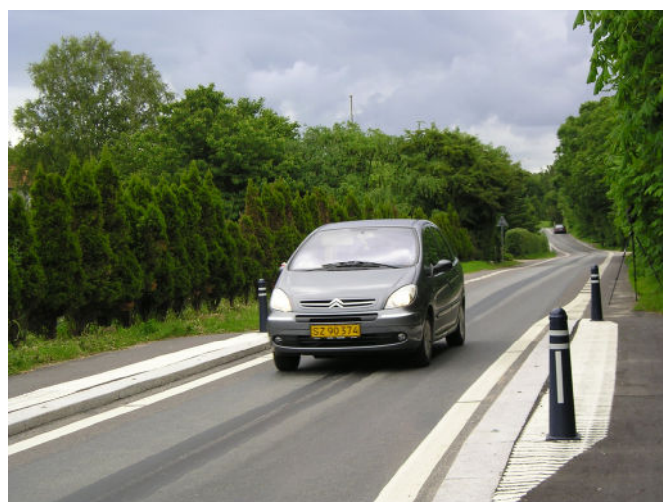
Figure 4: Speed reducer

The new "2-1"- profile is supplemented by 12 speed reducers - designed as 16 m long narrowings edged by side islands (see Figure 4).

- Mostly the meeting situations at speed reducers are handled without problems. The drivers seem to interact and adapt speed when approaching a narrowing letting the first arrival pass first. Problems are observed though in 5-10 % of the observed situations. It is not always quite clear to the drivers who should be the first to pass the narrowing. (see figure 4). In some cases both drivers stop and wait for each other to pass. In other cases one of the drivers continue without slowing down "forcing" the on-coming driver to give way. Accidents are observed in the narrowed speed reducers because of this confusion among drivers. A simple solution to this minor problem could be a sign telling the drivers who should go first.

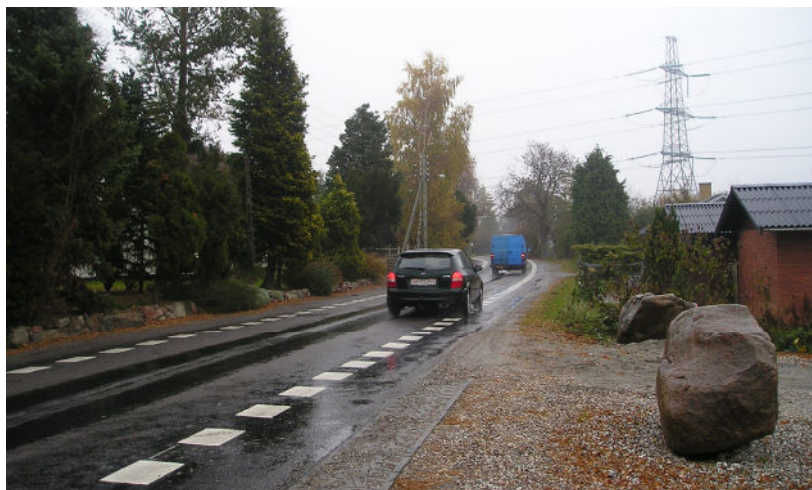
Figure 5: In meeting situations drivers give way to on-coming cars by crossing the intermittent edge line a little bit as intended.

- The drivers seem to behave as intended in meeting situations on road sections. Drivers give way to the on-coming drivers by changing the lateral position to the right and in some cases the right wheels are crossing the intermittent edge line a little bit as intended. On-coming traffic pass in both directions without problems even though the "2 minus 1" road has only one central driving lane (see figure 5)
